PRATT AND WHITNEY AIRCRAFT GROUP WEST PALM BEACH FL 6--ETC F/G 21/5  
DESIGN, FABRICATION, AND EVALUATION OF GATORIZED (TRADE NAME) C--ETC(U)  
JAN 79 S A MCLEOD, B H WALKER N00019-74-C-0484  
FR-9787 NL

REPORT DOCUMENTATION PAGE		READ INSTRUCTIONS BEFORE COMPLETING FORM
1. REPORT NUMBER FR-9787	2. GOVT ACCESSION NO.	3. RECIPIENT'S CATALOG NUMBER (9)
4. TITLE (and Subtitle) Design, Fabrication, and Evaluation of GATORIZED Ceramic-Wrought Alloy Attachment Concepts		5. TYPE OF REPORT & PERIOD COVERED Final Report 1 July 1974 through 31 July 1978

20. ABSTRACT (Continue on reverse side if necessary and identify by block number) The attachment of hot pressed silicon nitride material (HPSN) ceramic blades to a wrought superalloy disk, utilizing the GATORIZING® forging process, was developed and demonstrated for application in small gas turbine engines. The development of this hybrid attachment concept consisted of fabricating, optimizing, and evaluating single ceramic blade/wrought alloy attachments by spin testing at ambient and elevated temperatures. The hybrid rotor concept was demonstrated by designing, fabricating, and spin testing several fully-bladed hybrid rotors, some containi

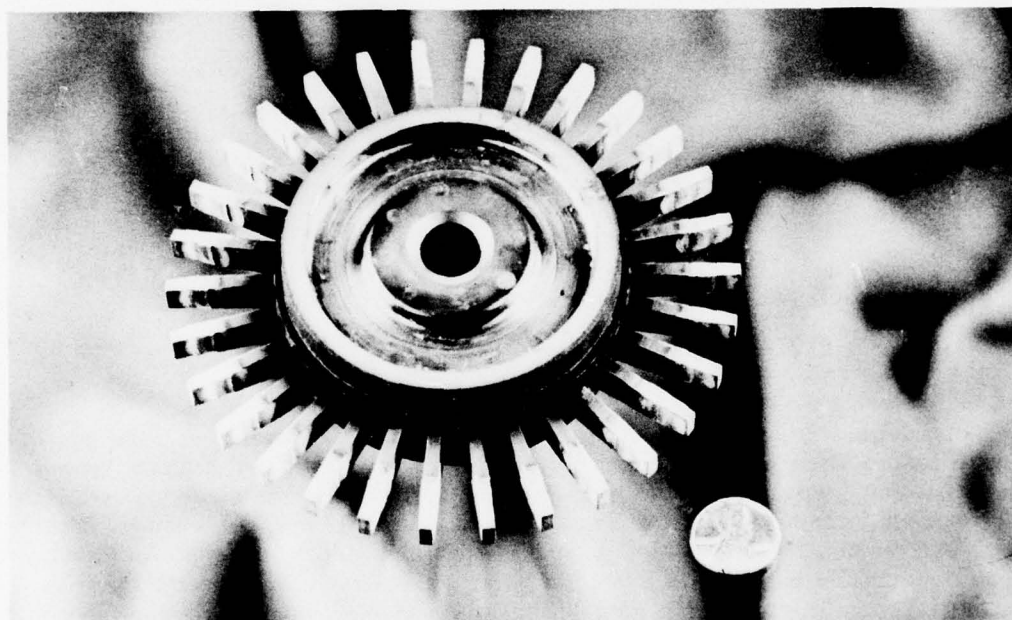
Figure 1. The Pseudobladed Hybrid Rotor After Completion of Program Milestone II Spin Test

The overall objective of this program was to develop and demonstrate the feasibility of a small gas turbine hybrid rotor consisting of a superalloy disk and ceramic blades. This objective was accomplished during a three phase effort consisting of (1) room-temperature development and characterization of a ceramic blade/superalloy attachment, (2) the development and elevated temperature spin testing of a fully-bladed, hybrid superalloy rotor containing ceramic pseudoblades (Figure 1), and (3) design fabrication, and elevated temperature spin testing of a hybrid rotor containing "airfoil" ceramic blades (Figure 2).

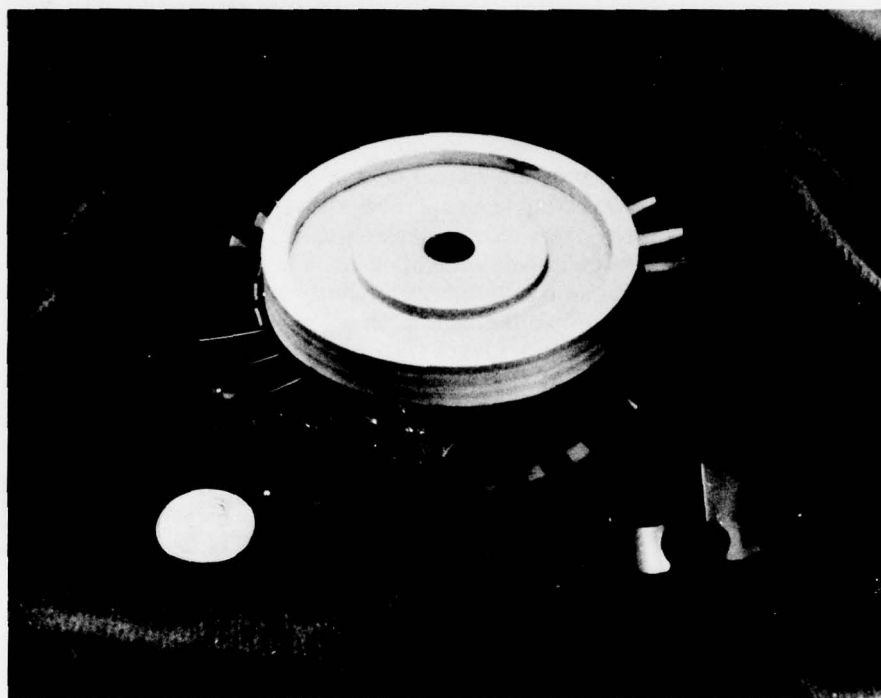
*Figure 2. Hybrid Airfoiled Rotor*

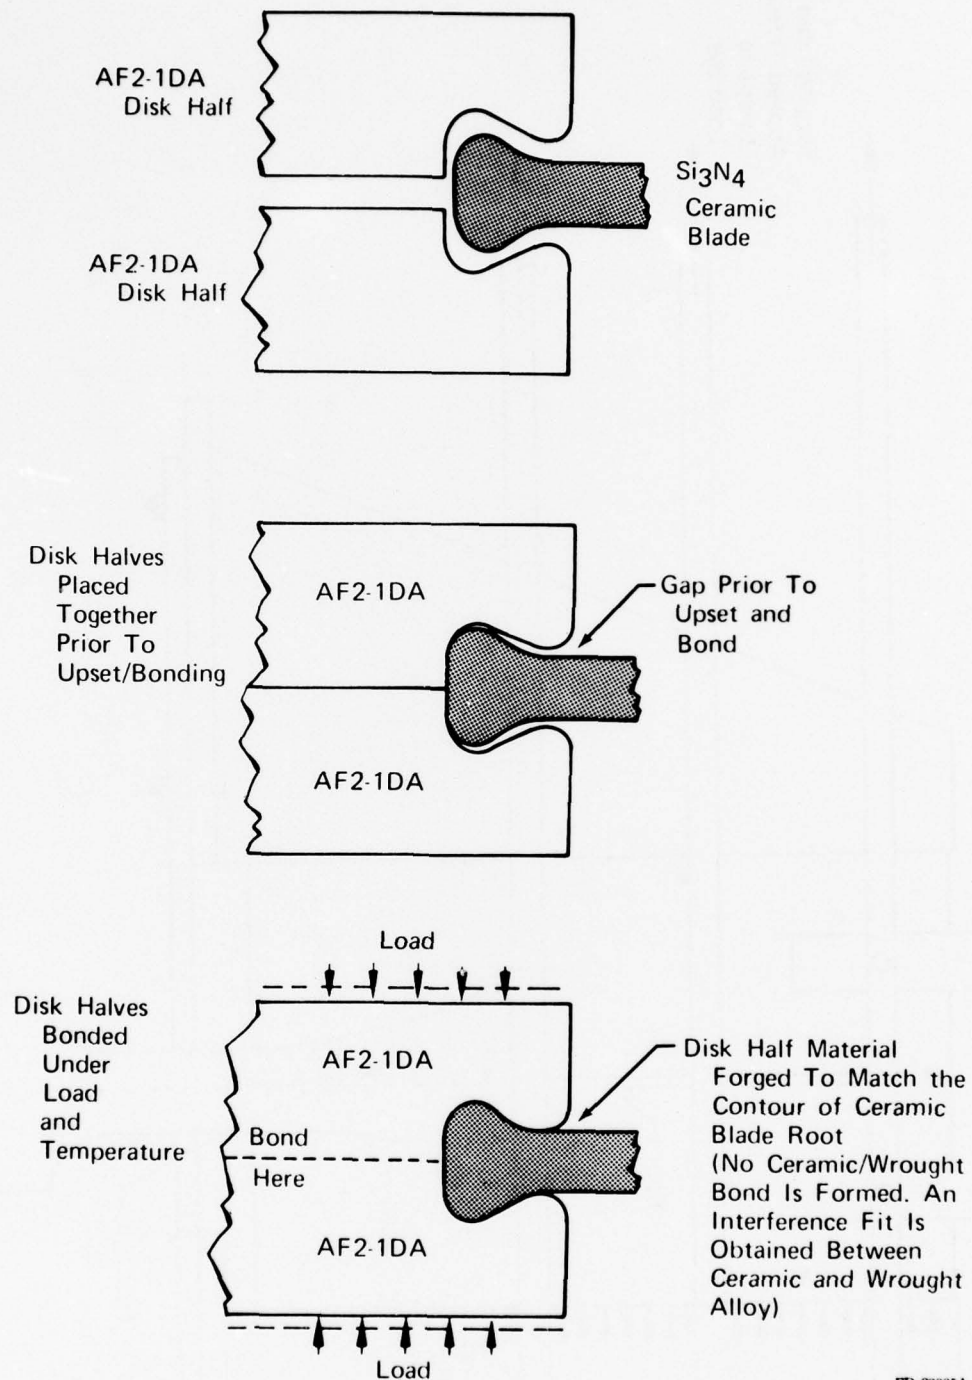
FD 92005A

Figure 3. Fabrication Process for the Ceramic-Wrought Alloy Attachment

After selecting the most promising attachment concept (Figure 3), an iterative study was conducted to optimize the load-carrying capability of the attachment. This optimization included: (1) photoelastic analysis, (2) forging process parameterization, (3) ceramic preheat treatment studies, and (4) a compliant layer study. The results of these analyses were evaluated by iteratively spin testing ceramic pseudoblade attachments to failure.

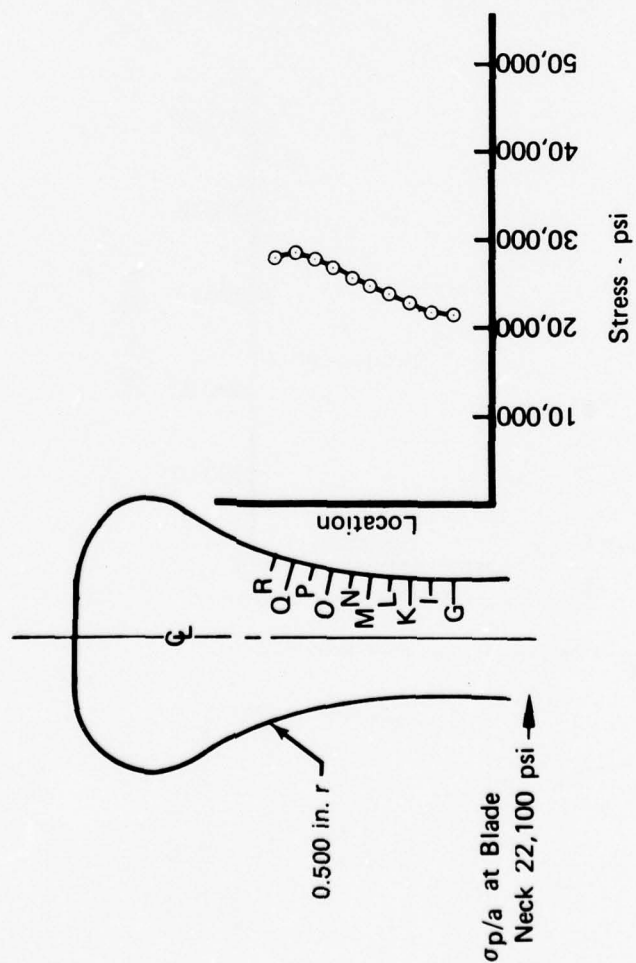
Figure 7. Result of First Experimental Blade Root Iteration

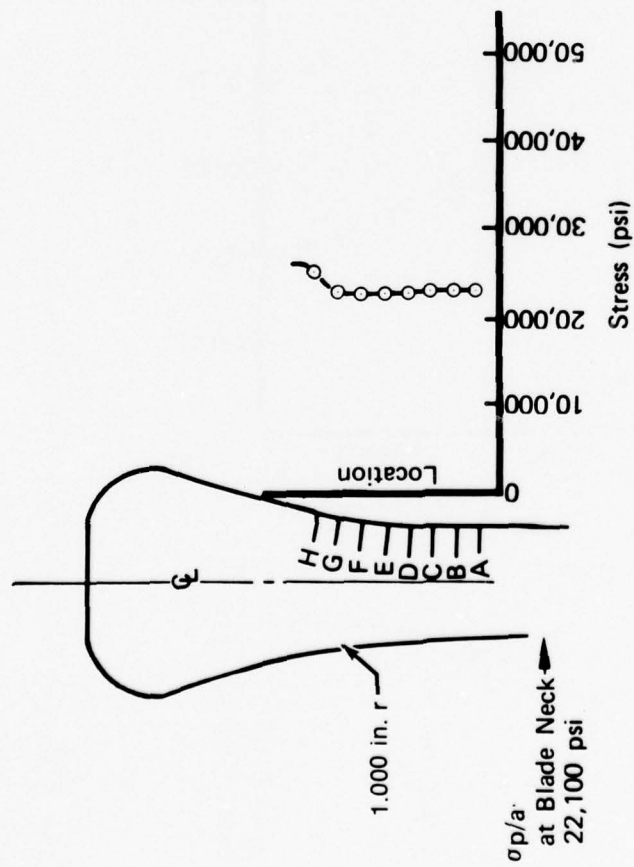
FD 86481C

Figure 8. Result of Second Blade Root Iteration

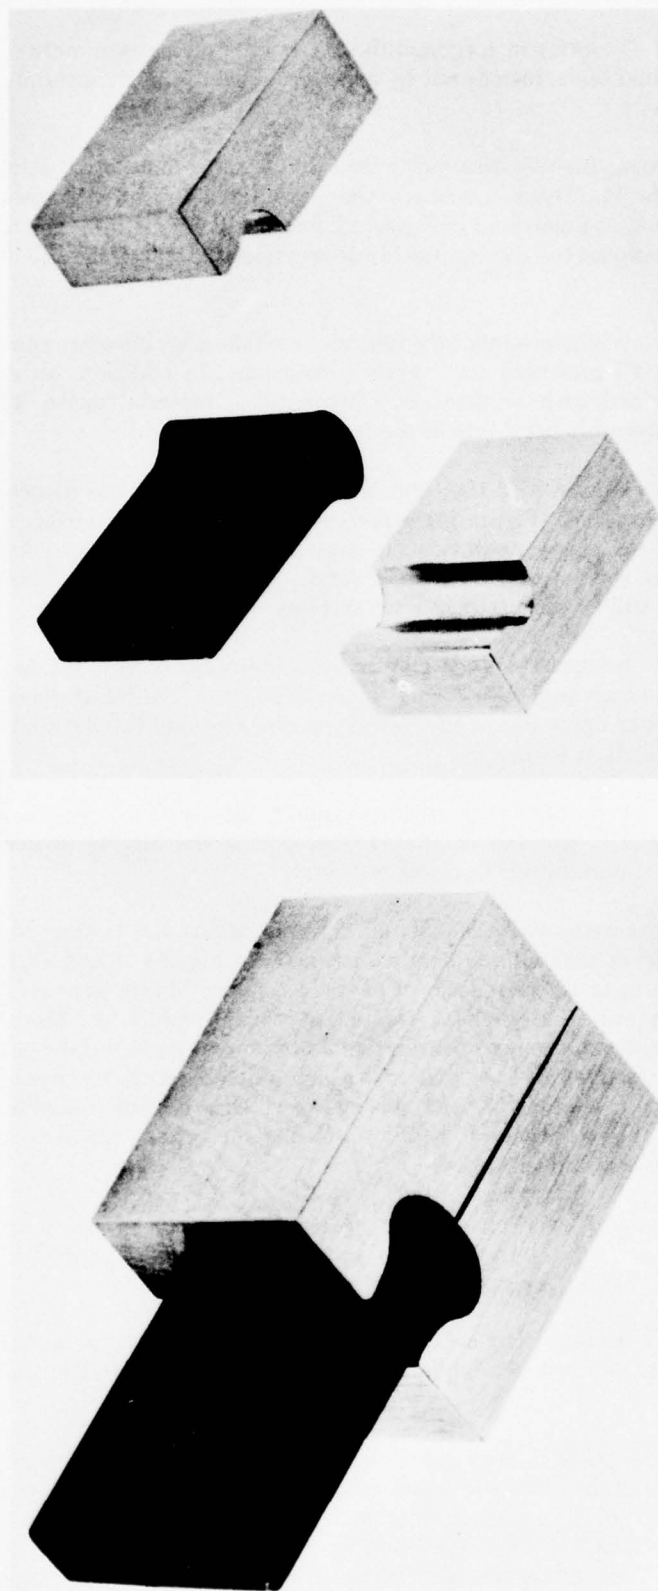
FD 86453

Figure 11. Specimen Using Dovetail Ceramic Blade Roots To Analyze the Forging Parameters

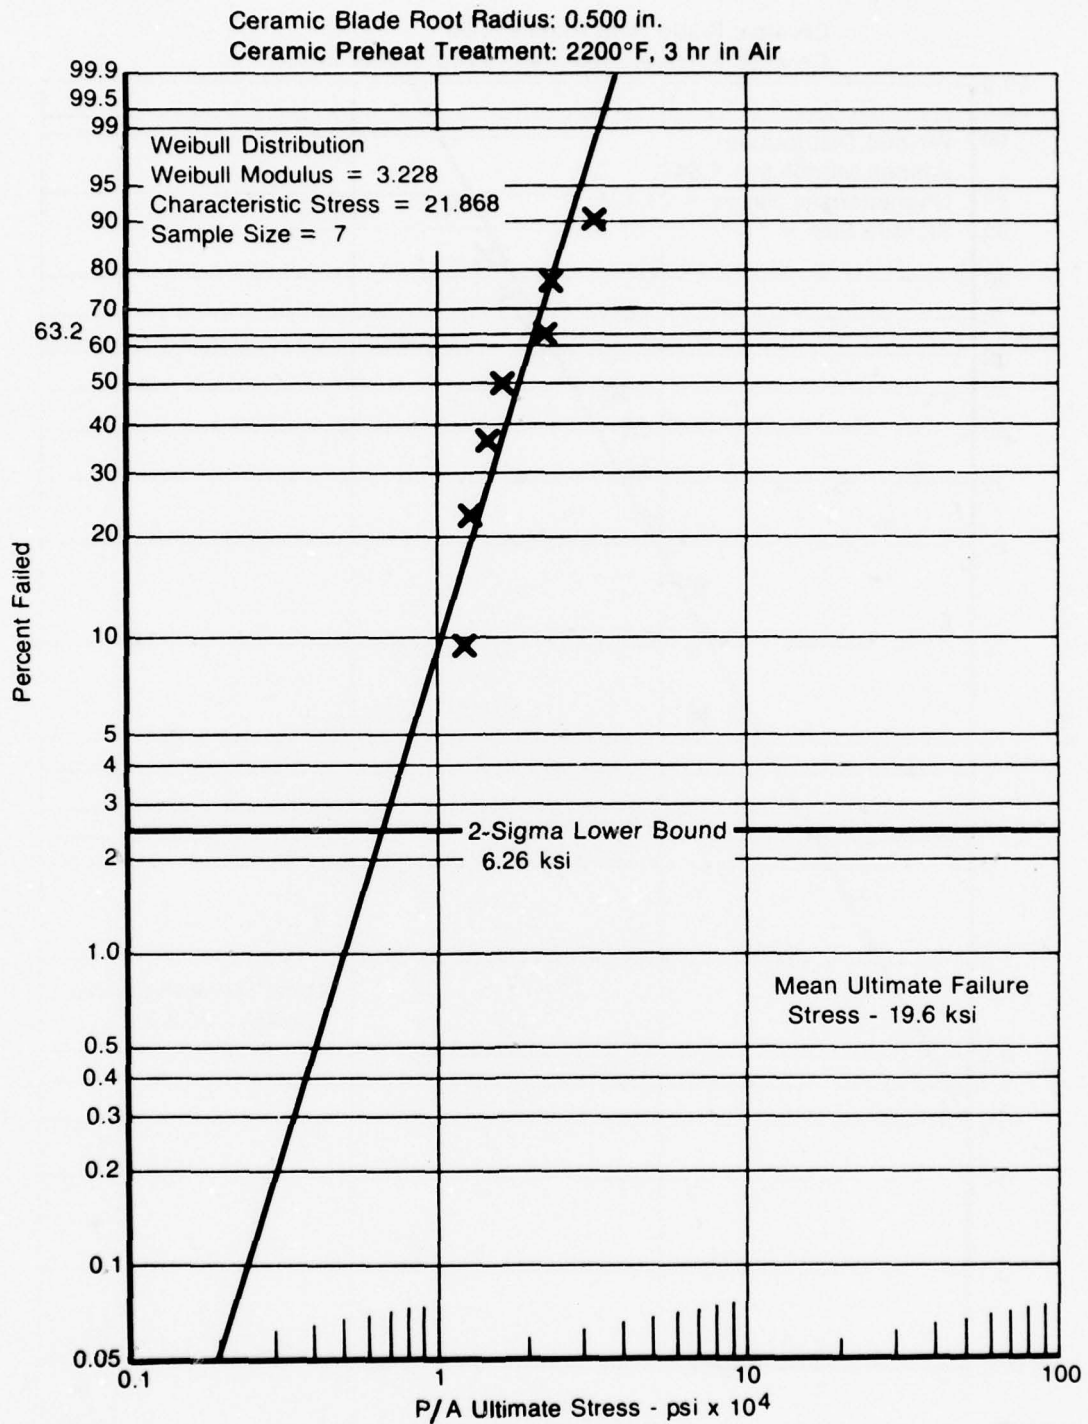
FD 94424A

Figure 19. Room-Temperature Ultimate Stress of Ceramic-Wrought Alloy Attachment

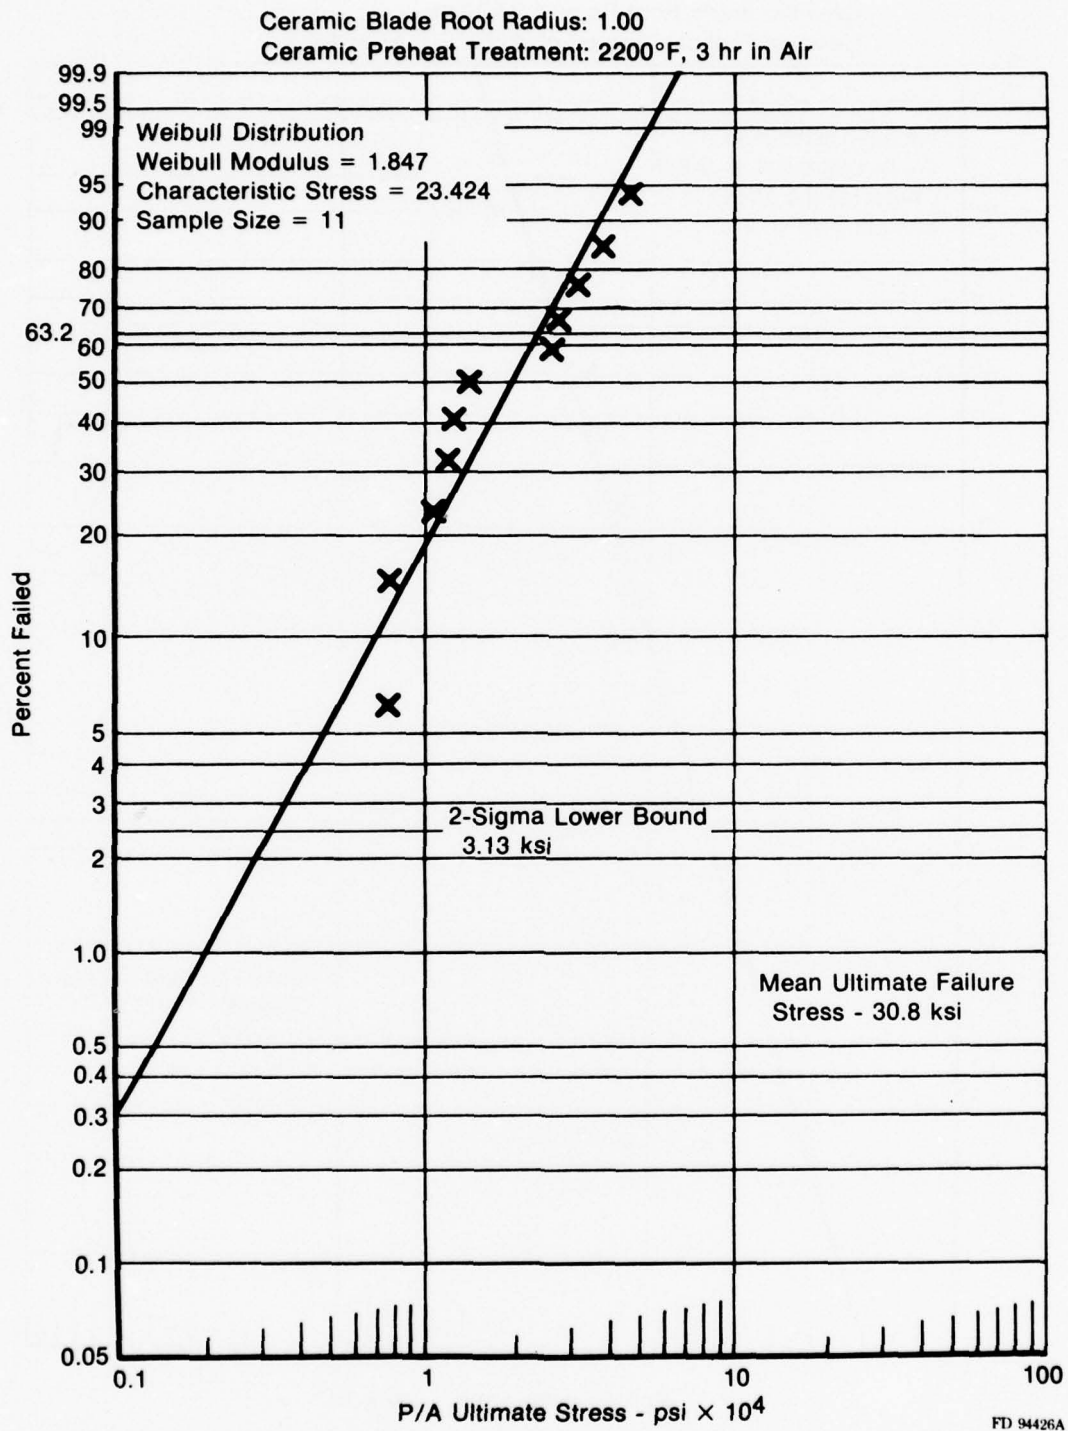
Figure 20. Room-Temperature Ultimate Stress of Ceramic-Wrought Alloy Attachment

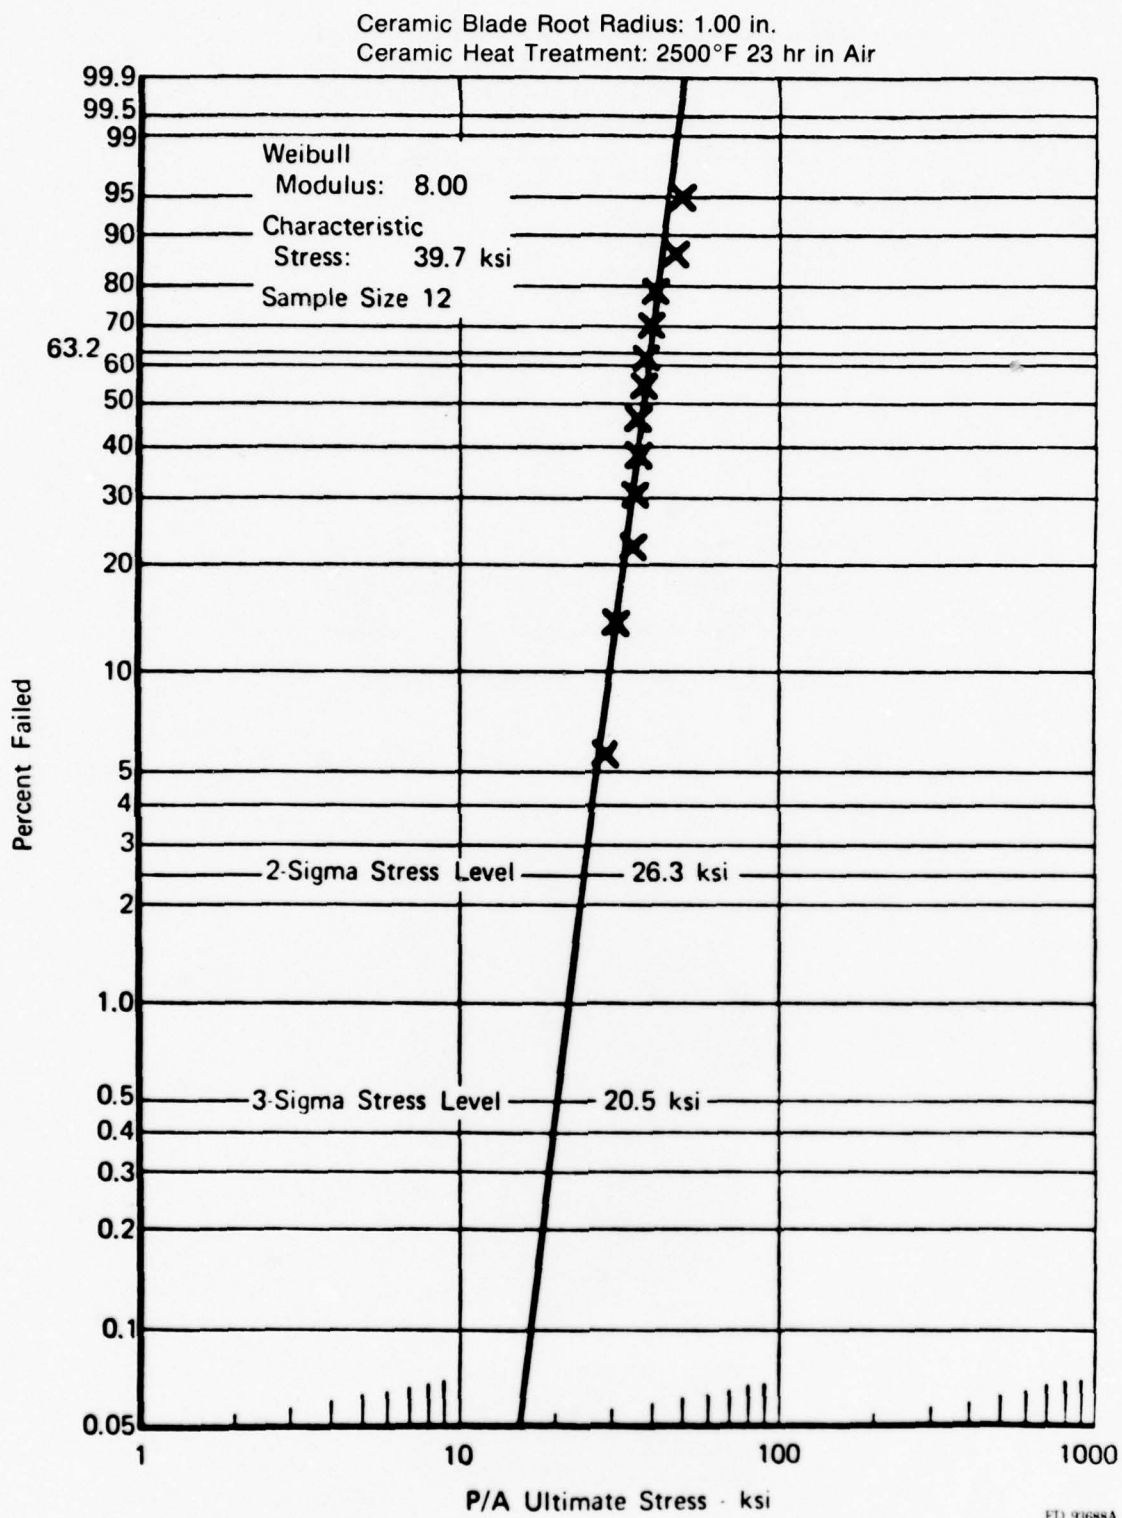
Figure 24. Room-Temperature Spin Test Ultimate Stress Weibull Analysis of Ceramic-Wrought Alloy Attachment Using Platinum Compliant Layer

Subsequently, 12 single-bladed "balanced" attachments similar to the previous assemblies (Figure 22) were fabricated and spin tested at room temperature as tabulated in Table 4. The results of these spin tests were analyzed using Weibull statistics by minimizing the squared deviations in the ultimate stress, as plotted in Figure 24. This distribution indicates a mean stress of 37.4 ksi, a 2-Sigma lower bound of 26.3 ksi, and a 3-Sigma lower bound stress level of 20.5 ksi, above which 99.5% of the failures should occur. These data show less scatter and higher mean and 2-Sigma stress levels than all previous data and are also compatible with turbine engine design requirements for ceramic materials. Thus, the design P/A stress and corresponding rotor speed to be used for program Milestone I spin testing were set at 20.5 ksi and 60,000 rpm, respectively, as discussed in the following paragraphs.

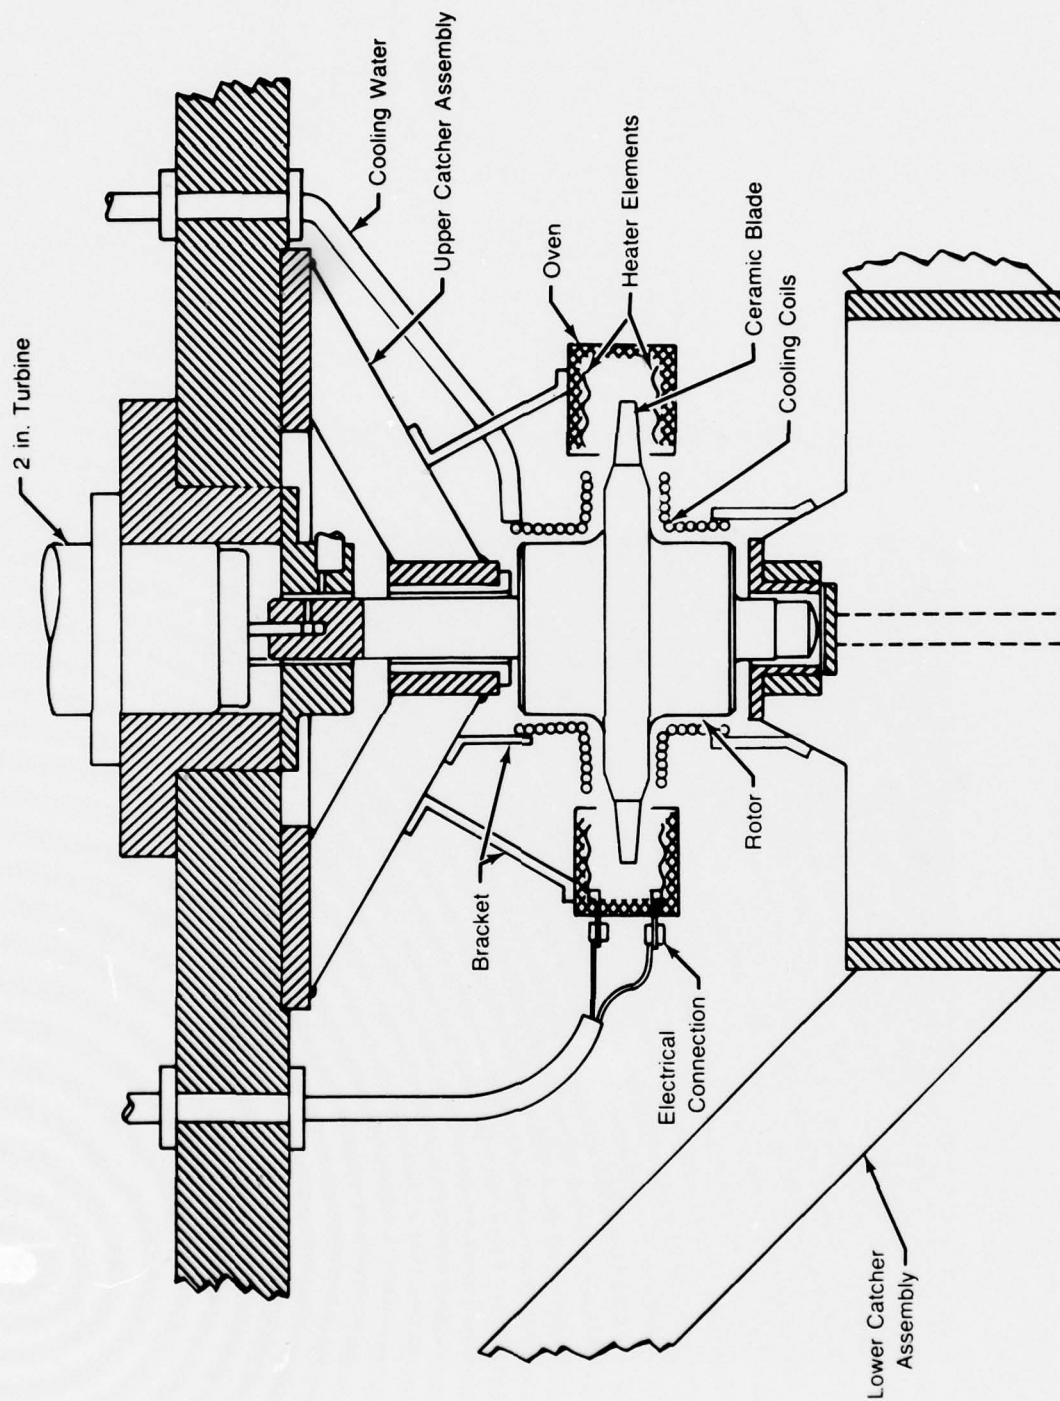
FD 96510

Figure 29. Schematic of the Photoelastic Analysis of the Elevated-Temperature Rotor

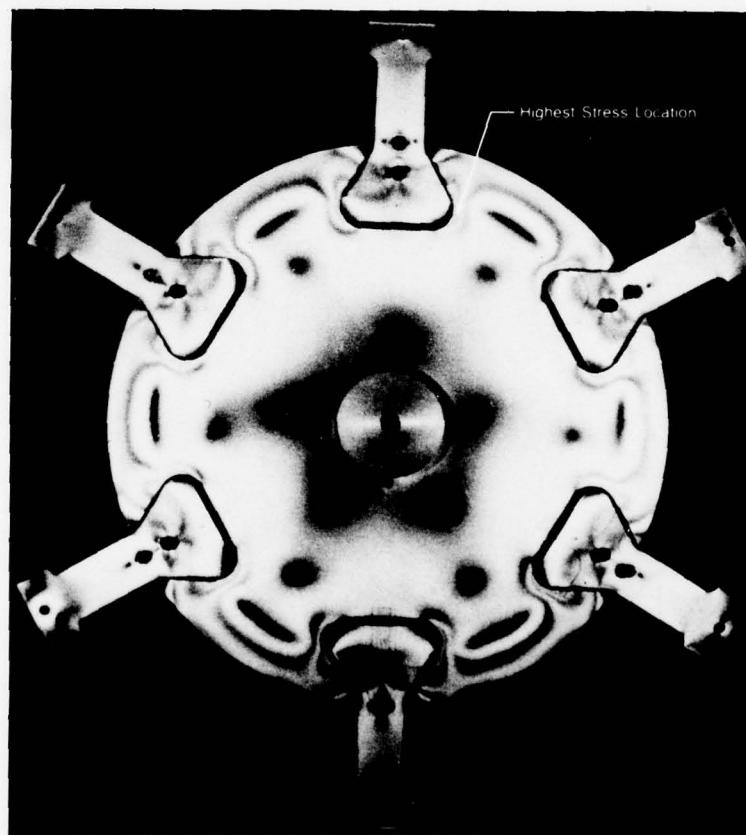
KFE 147318B

Figure 30. Photoelastic Stress Distribution of Six-Slotted Rotor

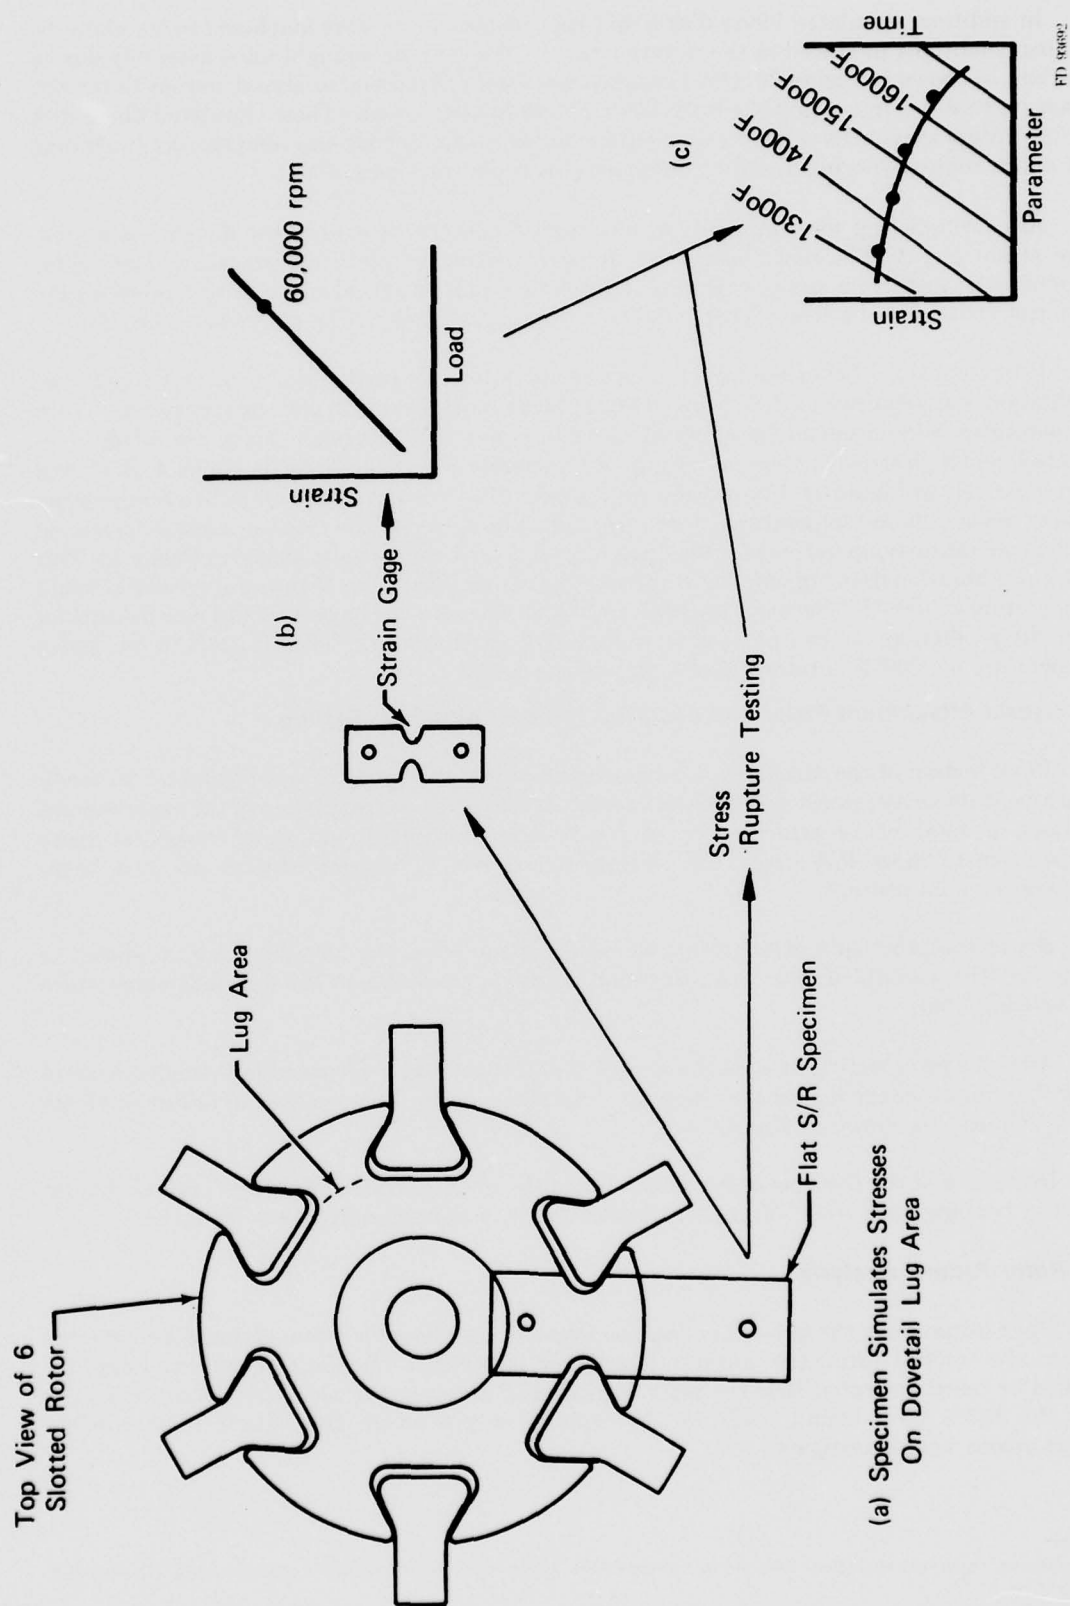
Figure 31. Flat Stress-Rupture Specimen and Analysis of Dovetail Lug Area

For this analysis, flat strain rupture specimens simulating the area and stresses between the rotor dovetail slots were fabricated, as shown in Figure 31a. Initially, one specimen was strain gaged and a strain vs load plot established, as shown in Figure 31b. The load in this case simulated the P/A loading at increasing rotor speeds produced by both the rotor lug mass and the ceramic-wrought alloy attachment. These flat strain rupture specimens were then tested to failure at various temperatures and loads. The loads at these elevated temperatures were correlated to the room-temperature strain, and a strain vs time and temperature plot was established, as shown in Figure 31c.

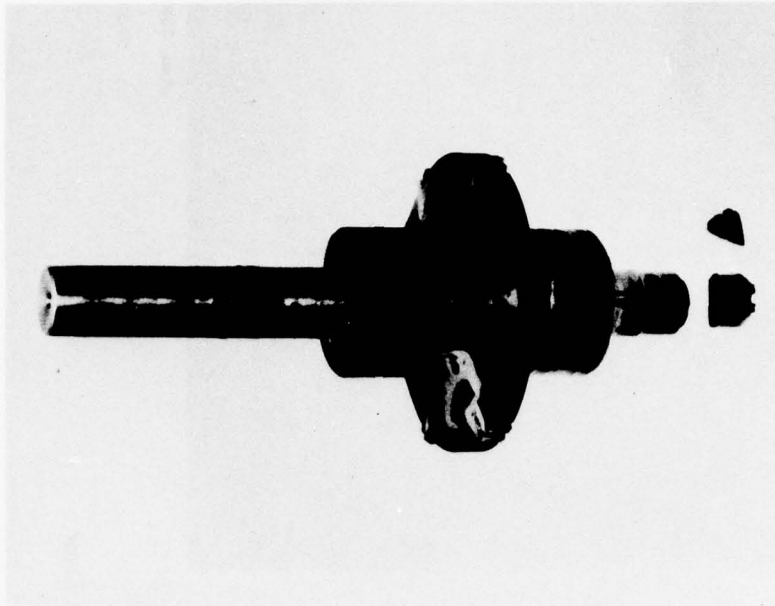
FAE 148144A

*Figure 36. Elevated-Temperature Rotor Failure*

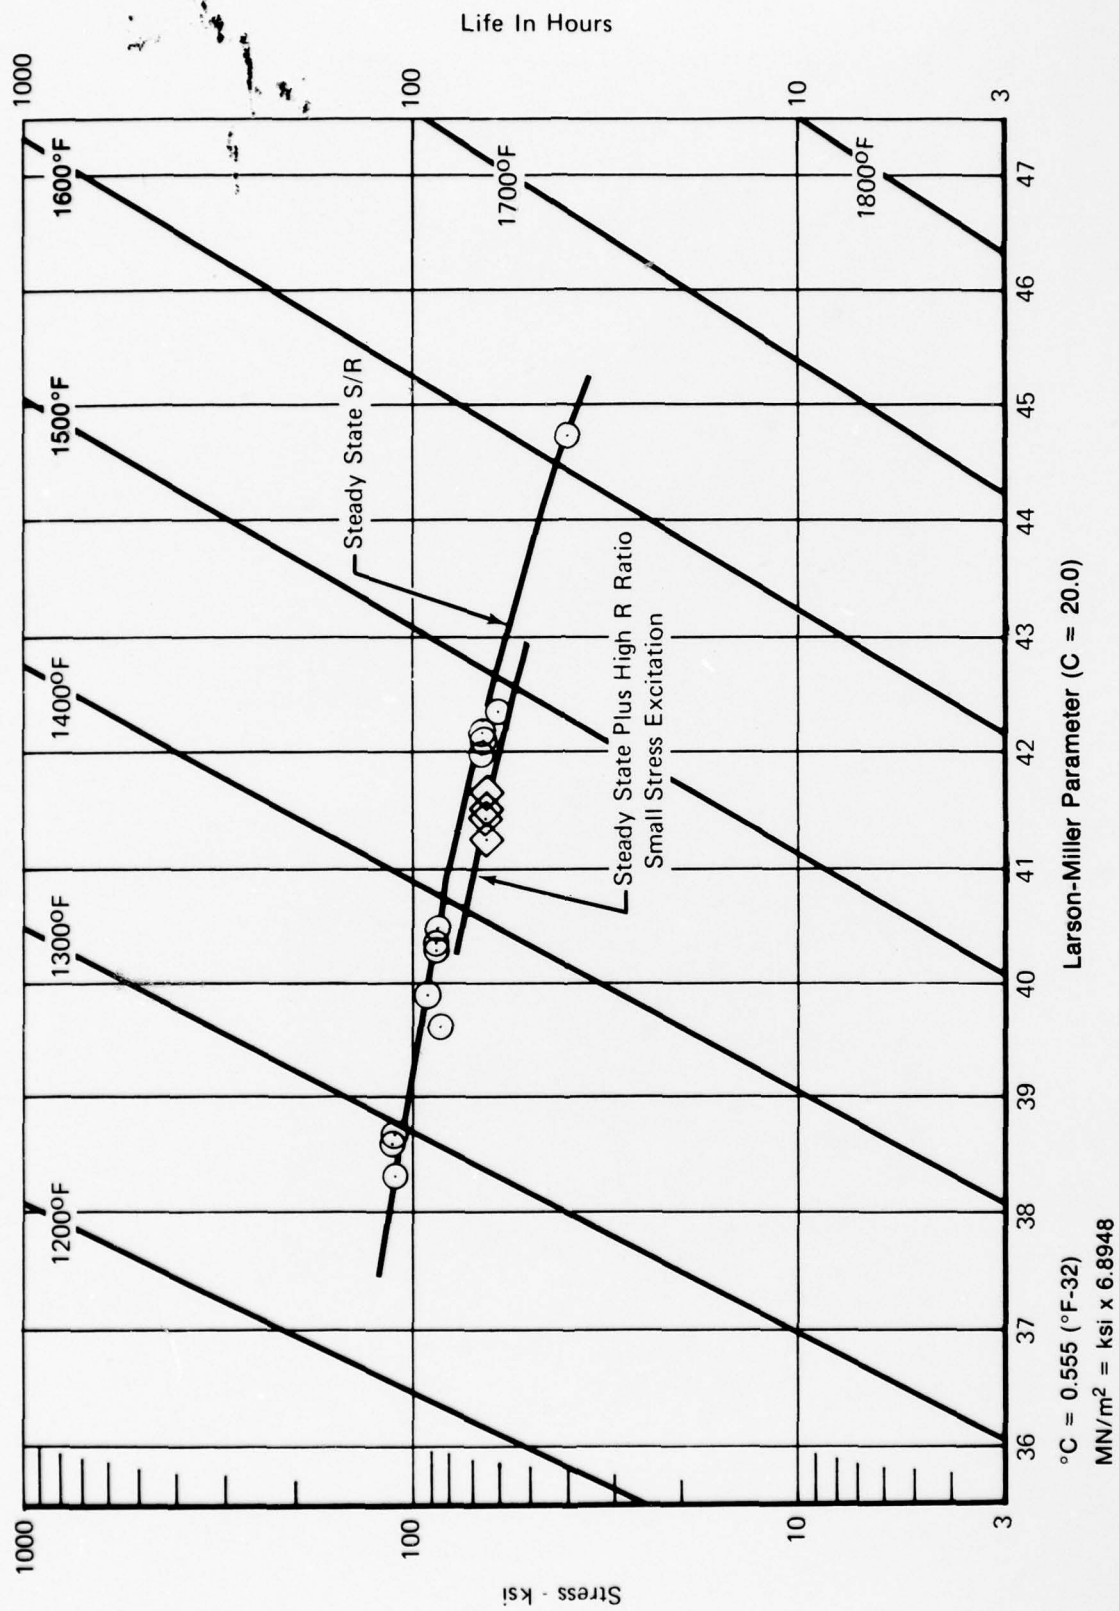
Figure 41. Effect of High R Ratio Small Stress Excitation on Stress-Rupture Life of IN 100 Rotor

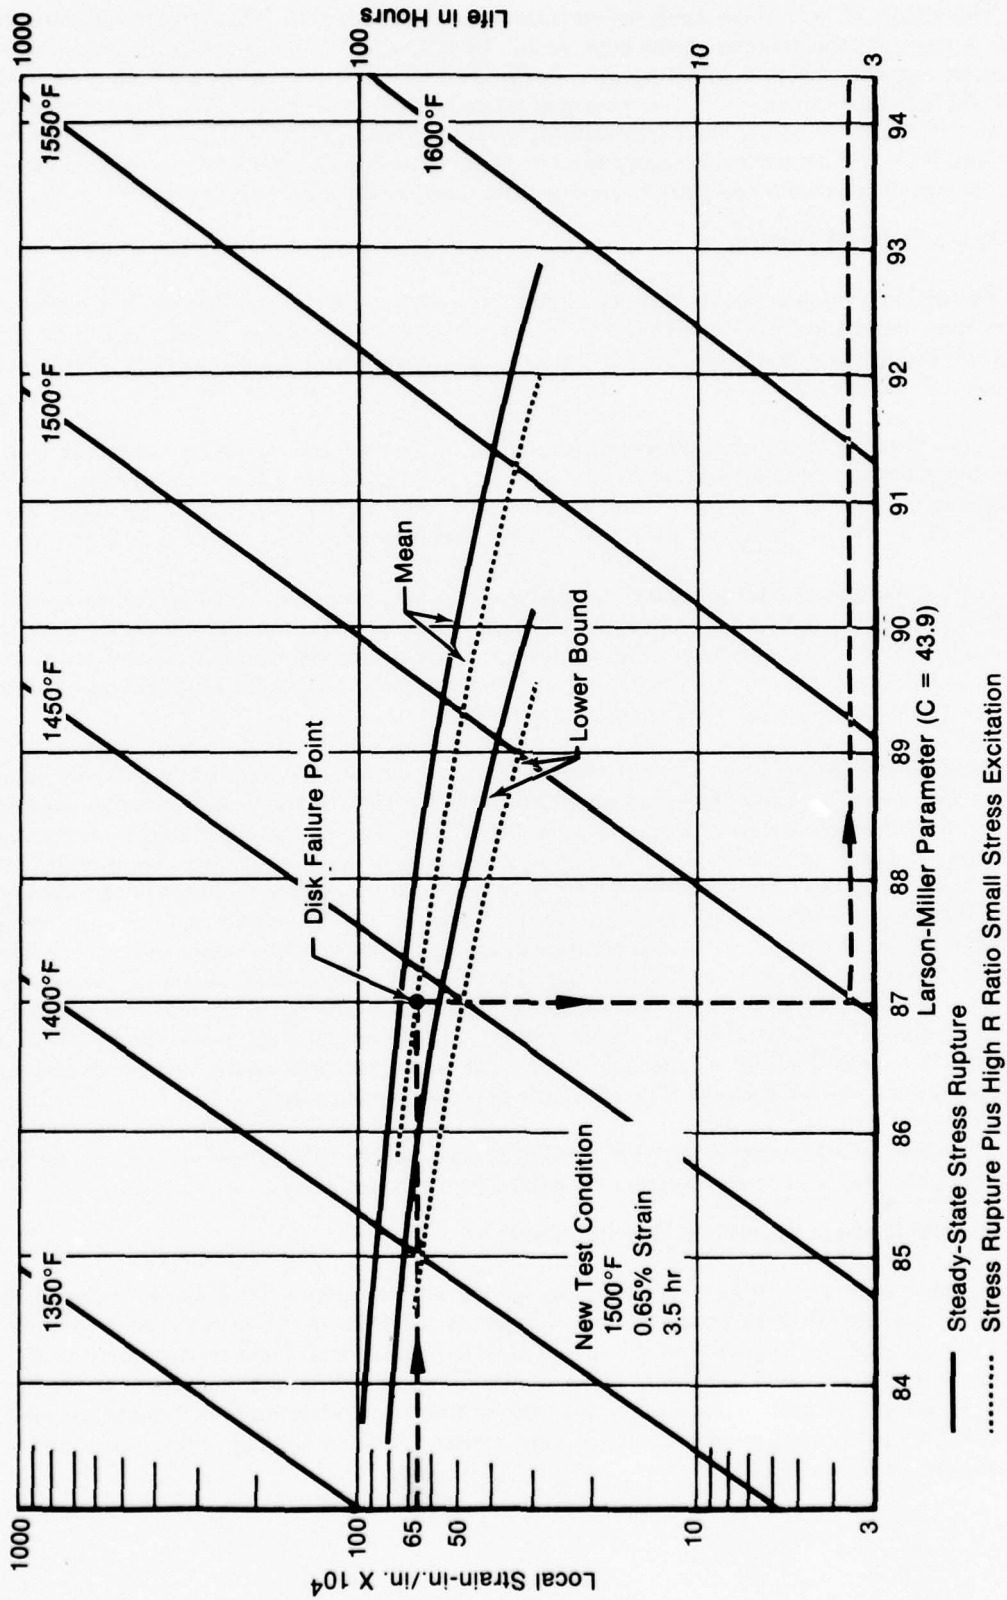
FD 97821

Figure 45. Results of Hot Spin Rotor Failure Analysis

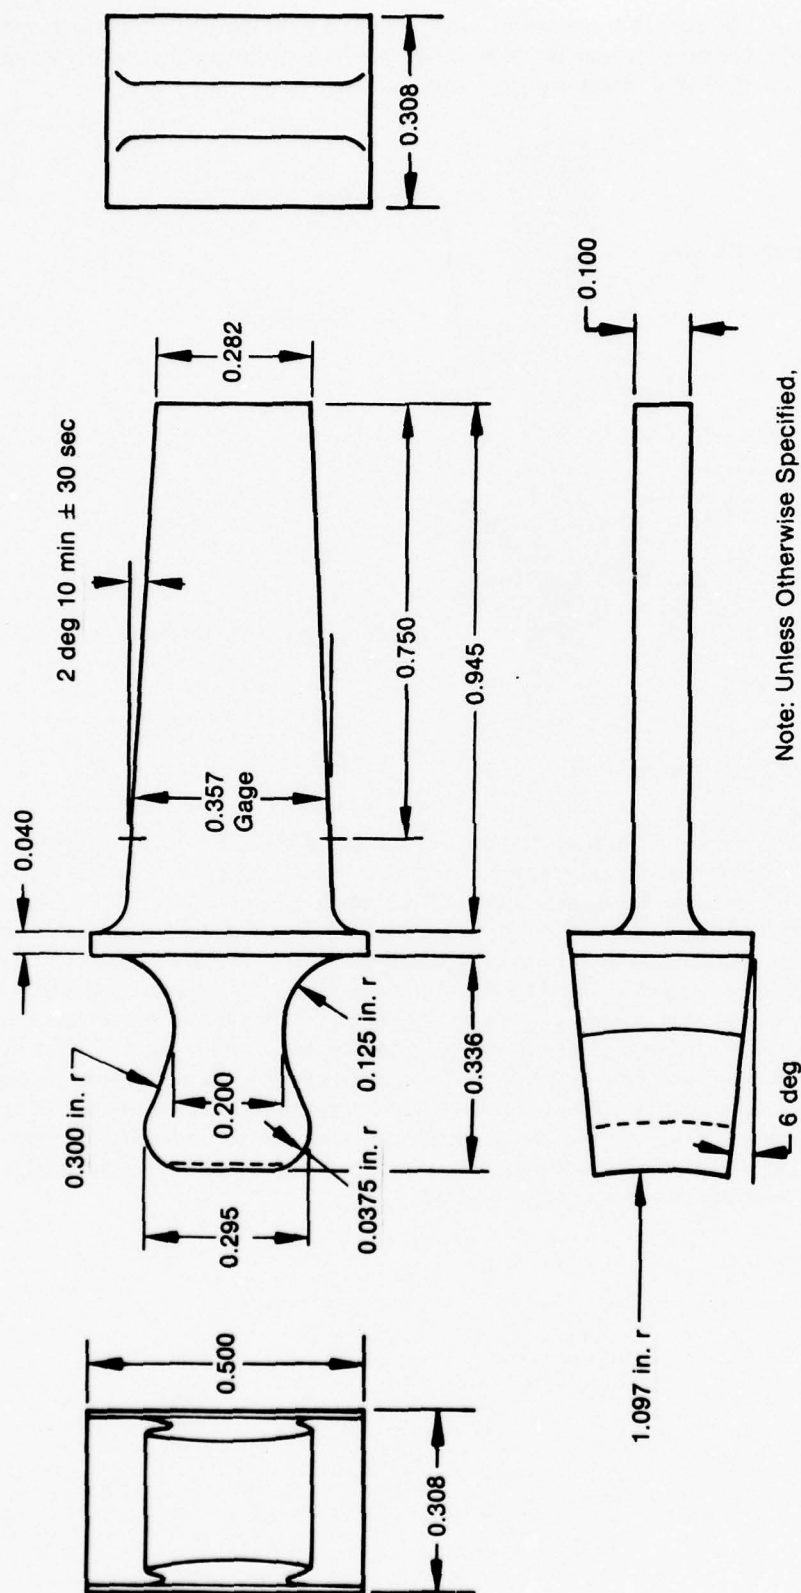
FD 97830A

Figure 48. Circumferential Root Ceramic Pseudoblade

Although previous spin testing did not show any advantage of the 1.00-in. root radius over the 0.500-in. root radius configuration, an assumption to this effect could not be made for the 0.300-in. root radius configuration. To investigate the load-carrying capability of the 0.300-in. root radius configuration, eight flat blades (similar to Figure 46) were fabricated and spin tested to failure using the room temperature spin tooling. These blades were not preheat treated, but were in as-ground and polished condition. The results of testing these specimens are tabulated in Table 7. A Weibull analysis of this data is also shown in Figure 50. Results of these tests were actually better than results of any previous spin testing. The 3-Sigma stress level of 39 ksi was a 90% increase over the 20.5 ksi 3-Sigma stress level previously attained in room temperature testing of 1.00-in. root radius blades. This increase in stress capability was attributed to the absence of any ceramic surface degradation due to oxidation and also to improve attachment fabrication techniques, rather than to a change in the root radius. These results substantiated the 0.300-in. root radius as a viable design for future testing.

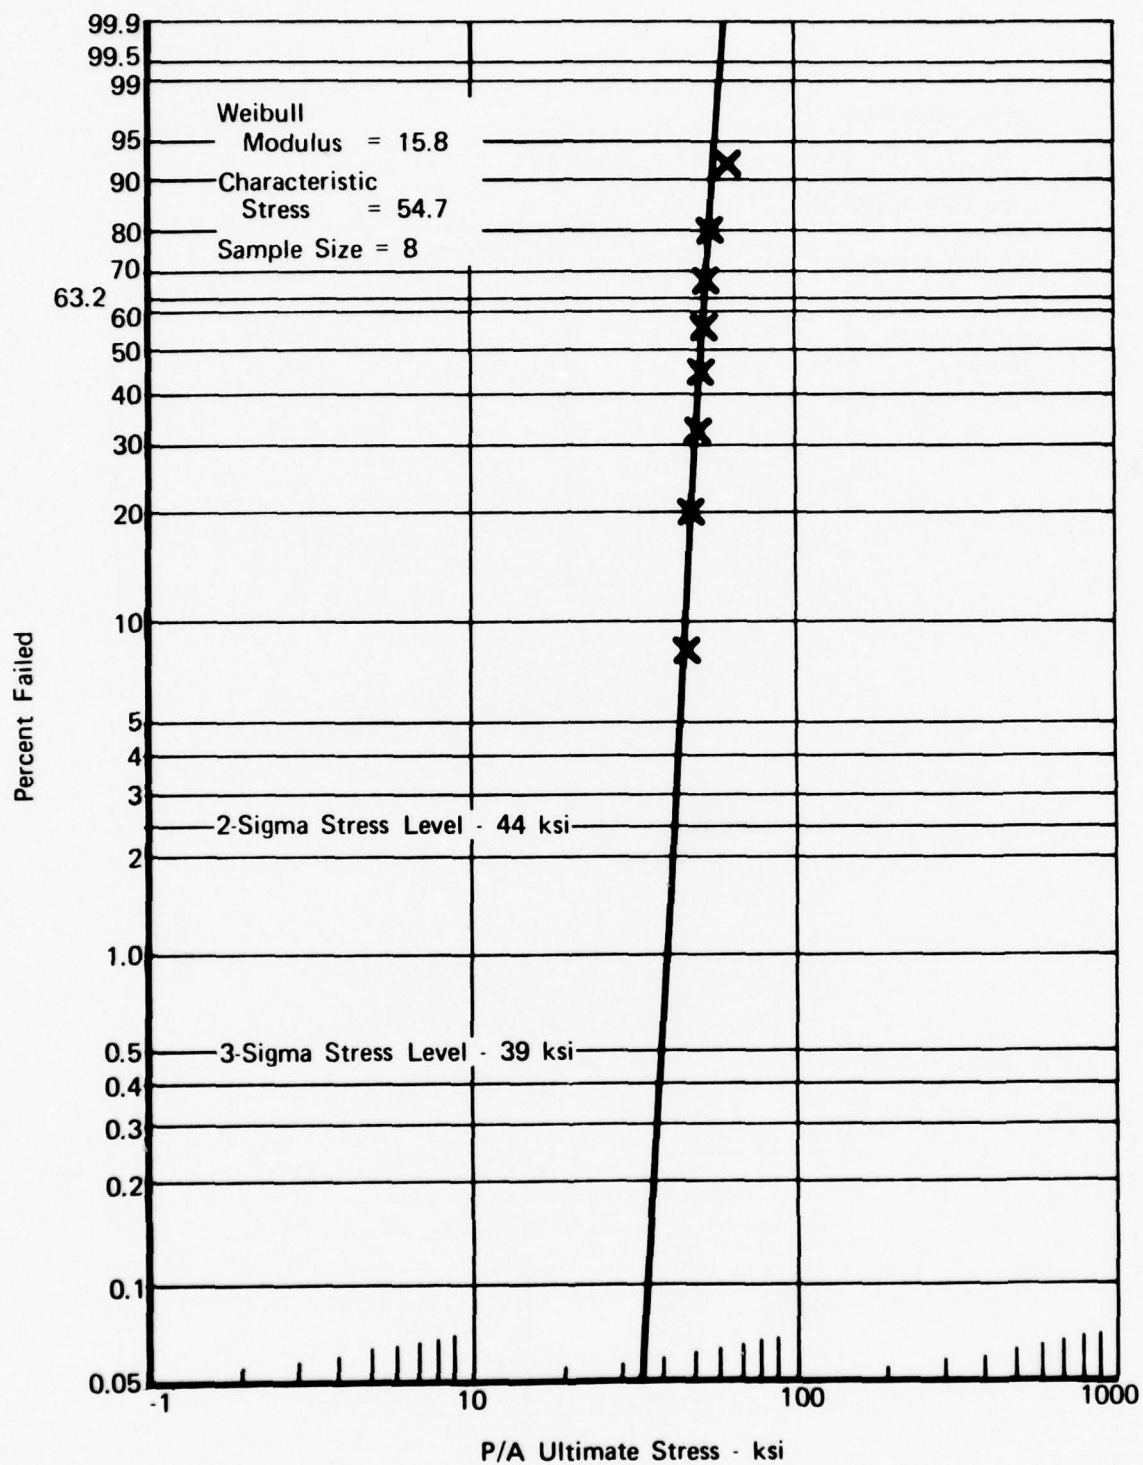
Figure 50. Room-Temperature Spin Test Weibull Analysis (Ultimate Stress of Ceramic-Wrought Alloy Attachment Using 0.300-Root Radius and Platinum Compliant Layer)

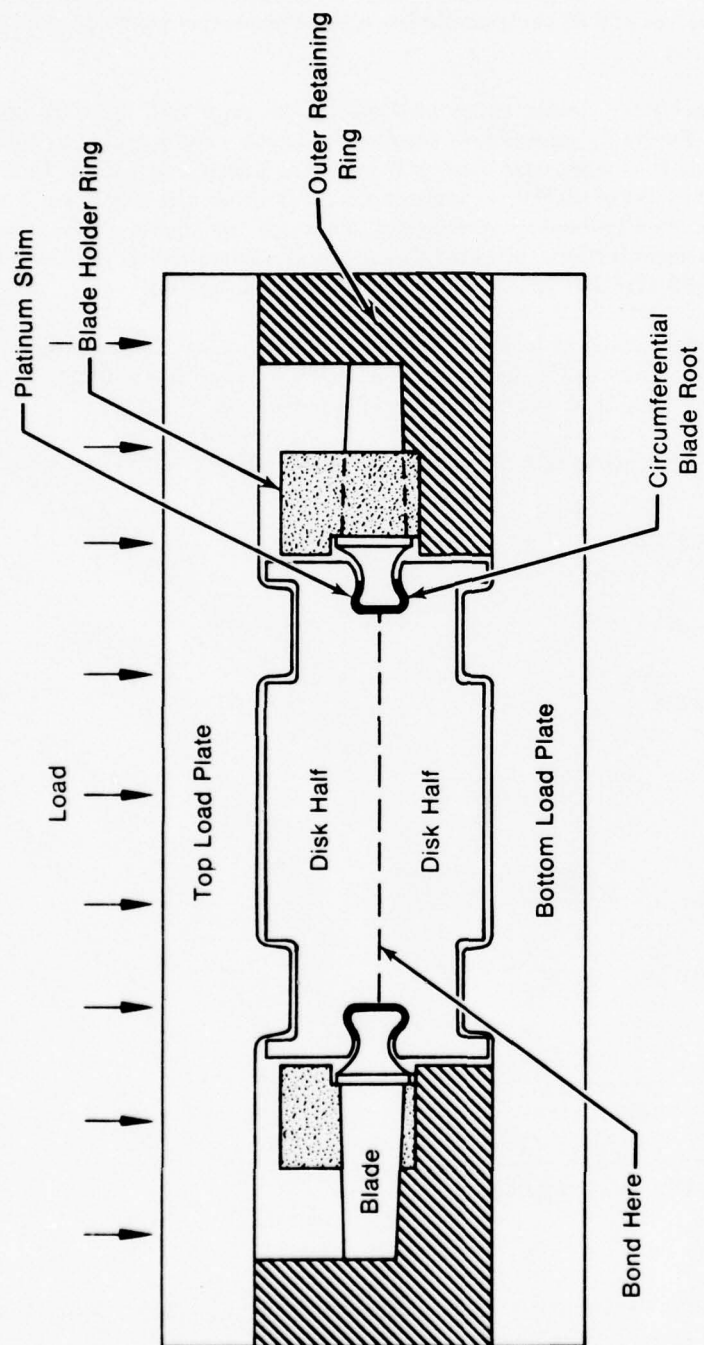
FD 105759A

Figure 51. Upset Diffusion Bond Tooling
